UH-60 AIRLOADS PROGRAM TUTORIAL

The UH-60A Airloads Program Tutorial was developed by NASA's Subsonic Rotary Wing Project under the Aeronautics Research Mission Directorate.

The purpose of the UH-60A tutorial is to augment helicopter graduate education courses based on the extent and richness of the UH-60A flight test database. Beyond this primary purpose, this tutorial can be used to provide an in-depth introduction to helicopter technology for anyone working in the field.

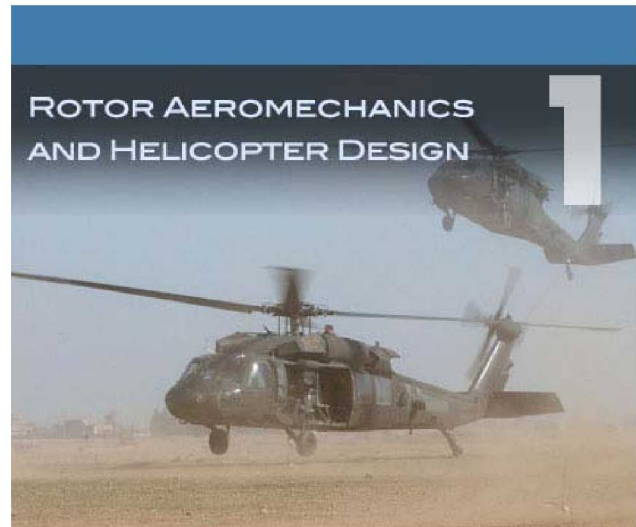
The seven aeromechanics design topics discussed in this chapter are:

1. Hover Performance
2. Vertical Rate of Climb (Military)
3. One-Engine-Inoperative OEI Performance
4. Performance, Loads, and Vibration at Maximum Cruise or Level Flight Speed
5. Loads in Critical Maneuvers
6. Vibration at Low Speed ([Transition](#))
7. Noise in low-speed descents

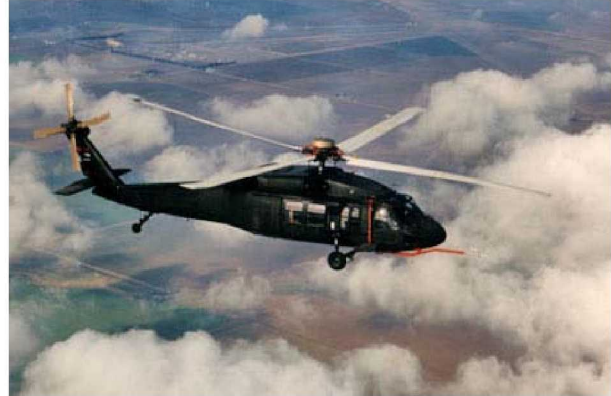
Hover performance must be calculated accurately. The accuracy of the calculation of [Figure of Merit](#) shown here ([Wachspress et al. 2003](#)) is better than 1%, although such accuracy is rarely achieved.

The UH-60A is a troop carrier and the weight of each troop is 1.5% of the aircraft gross weight. Errors of the order 1-2% may result in an aircraft that cannot carry its full complement of soldiers.

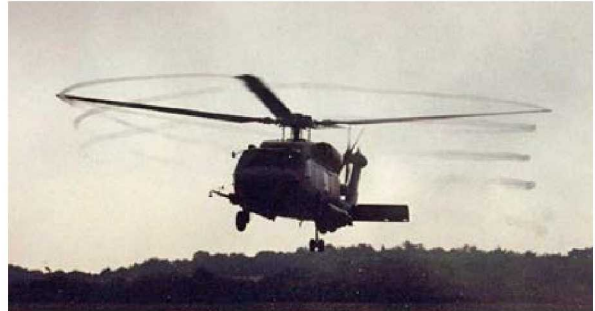
Vertical Rate of Climb (VROC) is a military requirement for additional power at the hover design point to allow for maneuvering. The required VROC is 500 ft/min for U.S. Army aircraft.

The figure shows that the power for vertical climb is overpredicted with current analyses (Felker et al. 1988). A nondimensional rate-of-climb between 0.2 and 0.3 is equivalent to $V_{ROC} = 500$ ft/min and for this case, the power is overpredicted by about 2.7%. From the designer's perspective the installed power is unnecessarily large and the rotor is not correctly sized.

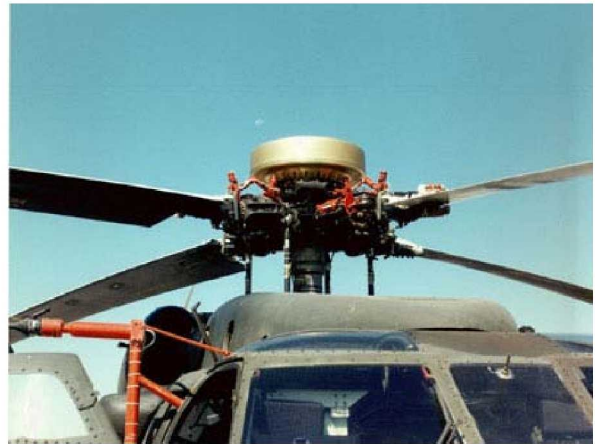
The 242 absolute pressure transducers were placed in nine radial arrays on the rotor blade, with slightly fewer transducers on the lower surface than the upper. The radial arrays were concentrated toward the blade tip, where the airloads are greatest. But note that there were also a few transducers located at intermediate radial stations near the leading edge of the blade.

These were installed to better study blade vortex interactions (BVIs). The pressure transducers were not temperature compensated, but the local temperature was measured at 50 locations along the blade. As of yet, no temperature corrections have been applied to the pressure measurements.

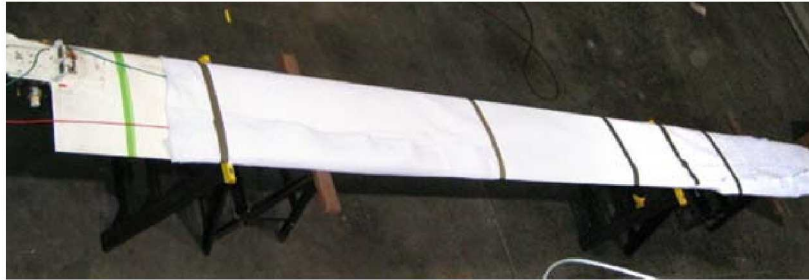
The flap and chord bending gauges on the blade were calibrated in the laboratory with the blade mounted rigidly at the root. The blade root was positioned at 0 and 180 deg. for the positive and negative flap bending calibration (negative flap bending calibration shown here). For the chord bending calibration, the blade root was positioned at 90 and 270 deg. Calibration loads were applied near the blade tip. The torsion strain gauges were calibrated with the blade mounted vertically, and pure moments were applied near the tip of the blade.

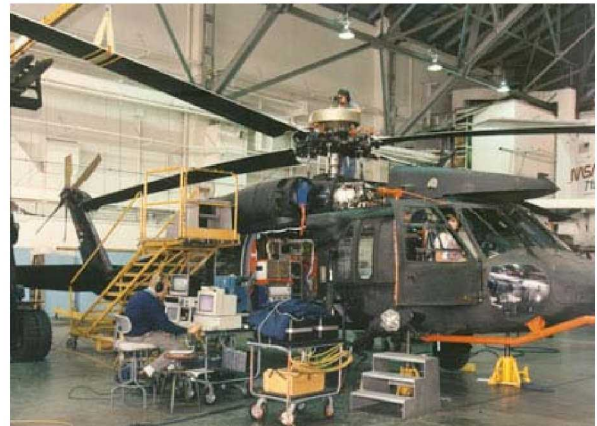
The UH-60A used two airspeed systems. For airspeeds below 20 knots, a Helicopter Airspeed Data Sensor (HADS) was used, while at higher speeds, the airspeed was measured with a pitot-static system on the test boom. The low-speed system was calibrated using a laser tracking system (and wind corrections were measured with balloon-borne anemometry). The high-speed system was calibrated, as shown here, from 80 to 160 knots using a T-34 aircraft with two independent calibrated airspeed systems. From about 20 to 70 knots, the high-speed system was calibrated using a pace car on the airfield runway.

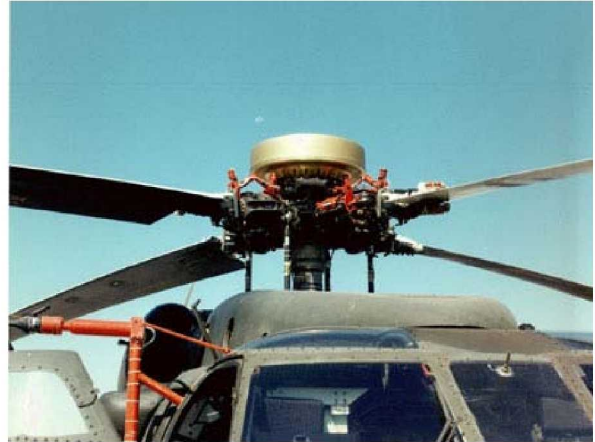
Most of the 242 absolute pressure transducers were chordwise arrays at nine radial stations. Slightly fewer transducers were on the lower surface. These chordwise arrays were concentrated toward the blade tip, where the airloads are greater. But note that there were also a few transducers located at intermediate radial stations near the leading edge of the blade. These were installed to better study blade vortex interactions ([BVIs](#)). The pressure transducers were not temperature compensated, but the local temperature was measured at 50 locations along the blade. As of yet, no temperature corrections have been applied to the pressure measurements.

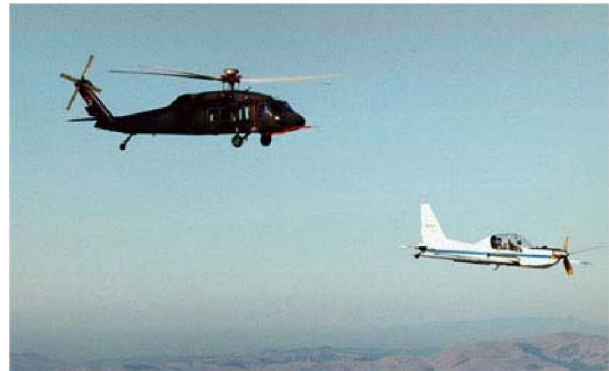
The UH-60A inflight-acoustic test matrix, in terms of flight path angle and advance ratio, is compared with the ground-acoustic test matrix shown [previously](#) for the Airloads Program (Figure 1 excludes most of the climb data from the ground-acoustic tests). The inflight testing focused exclusively on level and descending flight over a limited range of advance ratios. In part this was because of the flight envelope limits of the YO-3A, but also to focus on the approach condition for the UH-60A, which is centered around $\mu = 0.17$. Two weight coefficients were flown: 0.071 to match the DNW tests discussed below and 0.086 to examine the effects of rotor thrust on noise.

Figure 2. Click the arrow to see the UH-60A inflight-acoustic test matrix compared with test points from an 0.17-scale model test of the UH-60A rotor in the [DNW](#) in 1989. The full-scale UH-60A flight data overlap the model-scale data, and obtain high resolution in terms of flight path angle near the UH-60A's approach speed of $\mu = 0.17$.
